RAILWAY INVESTIGATION REPORT

R04M0032

MAIN-TRACK DERAILMENT

CAPE BRETON AND CENTRAL NOVA SCOTIA RAILWAY

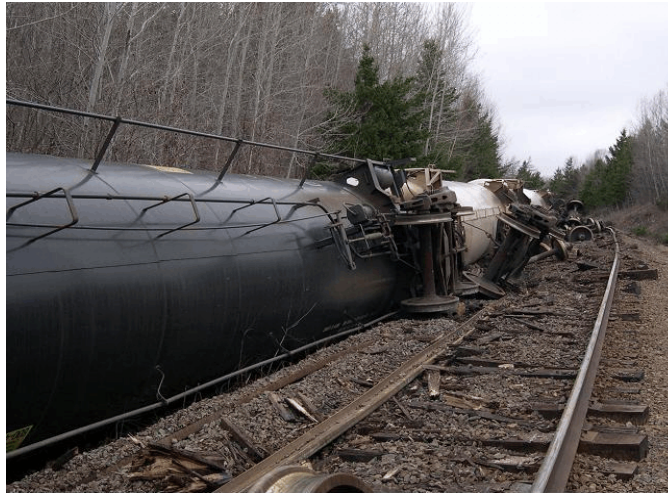
The TSR require a minimum of 10 crossties, in good condition and effectively distributed, for each 39-foot segment of rail. There were 26 defective ties (split, spike-killed, or broken) out of 93 ties between the entry of the spiral and the point of derailment, which is within TSR allowable limits. Several locations had two defective ties in a row; others had up to four defective ties in a cluster (Photo 7).

Photo 7. View of ties and rail near the initial derailment location

- In locations where clusters of bad ties exist, the ability of the track structure to restrain the gauge spreading forces exerted on it is greatly reduced. Rail fasteners need to have high stiffness in order to reduce the lateral rail deflections under load to reduce rail spreading. As there was a history of wide gauge through a third of the curve, the derailment could have occurred anywhere in a cluster of bad ties.

1. The train derailed as a result of a combination of track conditions (excessive superelevation, wide gauge, and defective ties) when rigid pressure tank cars, which are prone to derailment in areas of track irregularities, were negotiating an entry spiral of a three- to four-degree compound curve at underbalanced speed.

Cape Breton and Central Nova Scotia Railway (CBNS) has put a program in place to identify and prioritize areas where excess superelevation conditions exist. This program covers maintenance, tie installation, and curve elevation reductions. Fifty-seven curves with excess elevation were identified on the Hopewell Subdivision. Fifty-one have already been repaired, and the balance will be corrected in the 2005 Tie and Surfacing Program.

- approximately 21.4 miles of surfacing was performed;
- over 21 000 feet of gauging was performed; and
- 10 234 ties, as well as additional spikes, were installed.

CBNS has been working at eliminating the 100-pound rail by scrapping the low rail, transposing the high rail to the low side, and installing new 115-pound rail on the high side. To correct areas where there was ballast settlement (e.g., rail joint locations), a tamping machine was incorporated into the rail installation program to ensure loose and hanging ties were installed tight to the rail.
